Technical Service Bulletin

25-TSB-463-EN

Models and Markets: All STATIM 2000 and 5000 units with G4+ LCD controller boards worldwide

Description: Software update available SL12R102 (for G4+ LCD controller boards only)

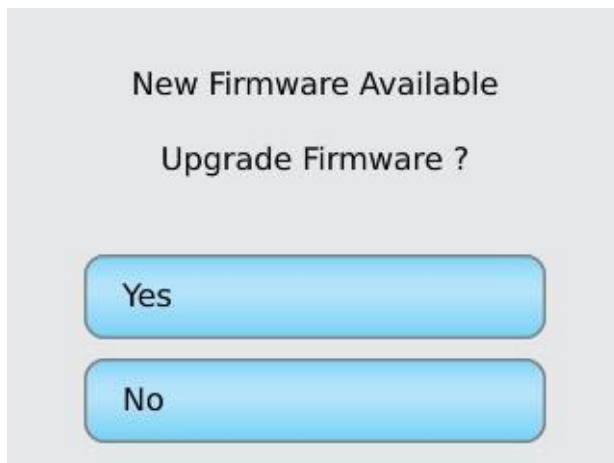
If the unit is connected to the Internet, it will have automatically received a new software available notification. Follow the screen prompts to download the software and update the unit. Note that the upgrade file is very large and depending on the user's network infrastructure (configuration and speed) this could take over an hour. Best practice is to accept the upgrade at the end of the workday to allow the upgrade to complete overnight.

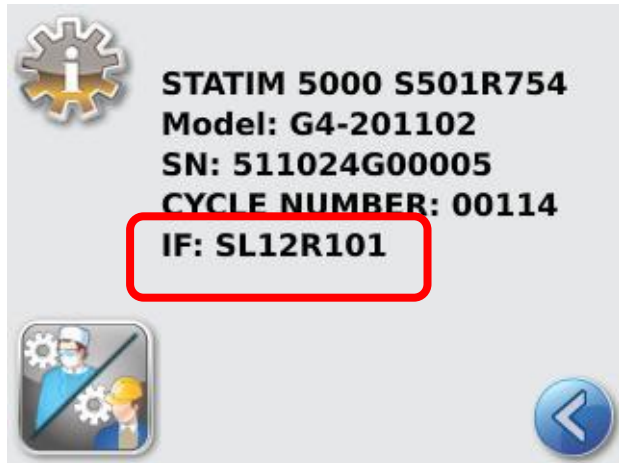
1. Check the information screen to see the software version.

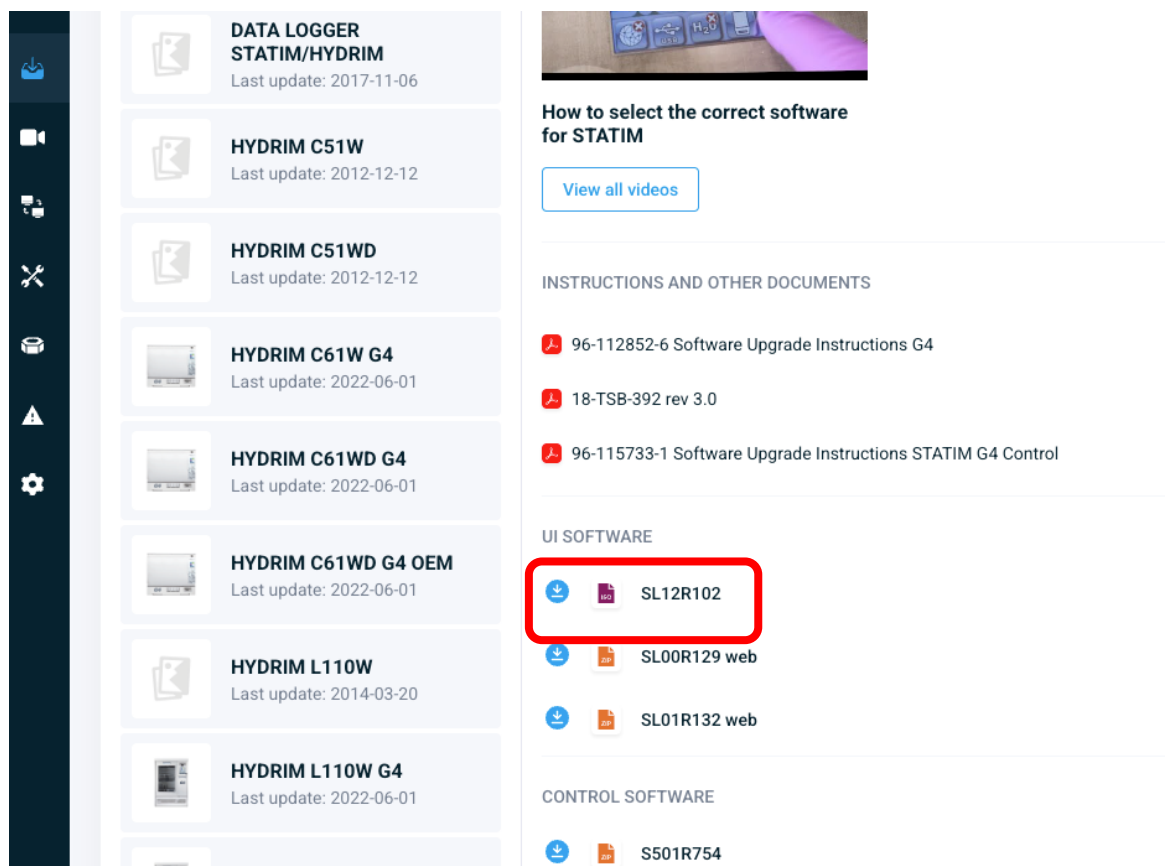
2. Download the file from myCOLTENE.com.

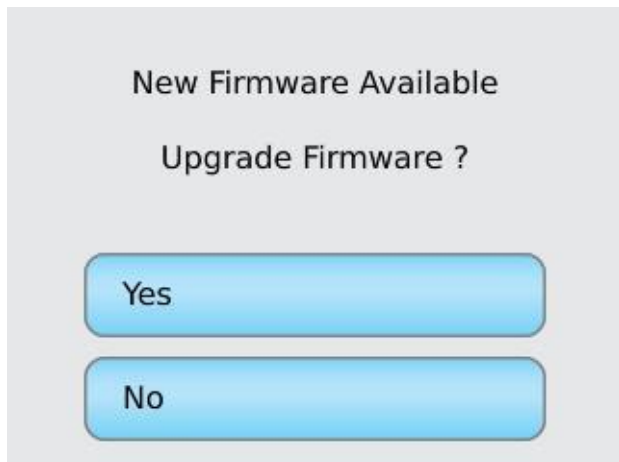
6. A message will show that new firmware is available.

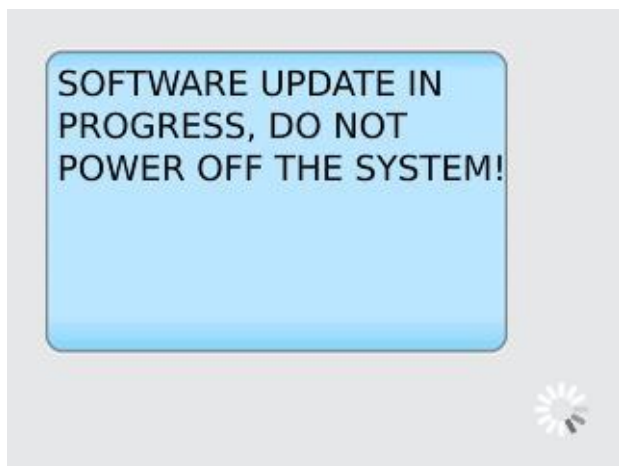
7. Press YES to start the upgrade.

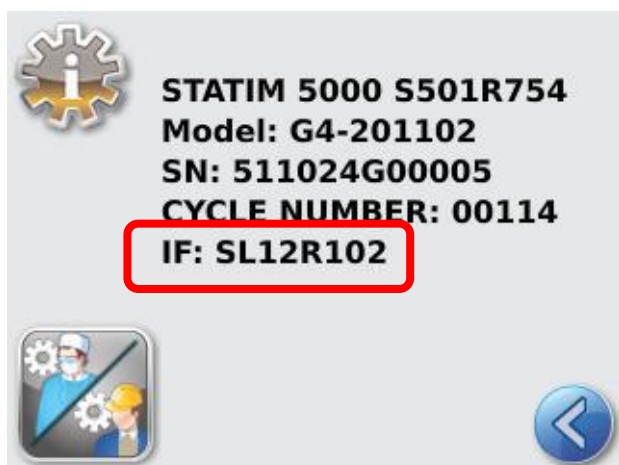
8. The update will take approximately 25 minutes. When it is complete, the unit will restart. Press the information screen to check that the unit software has upgraded.
